Setting: A group home with mentally handicapped clients who have a history of being very hard on the equipment. All the clients use this particular bathroom, including one who is visually impaired.

Need: A toilet safety frame had been installed on the toilet, but kept getting pulled loose making it hazardous. It was also an obstacle for other clients. One client needed a very sturdy, stable and durable assist to allow him to push up and to use as a balance when standing by the toilet. Other clients needed the assist to be out of the way.

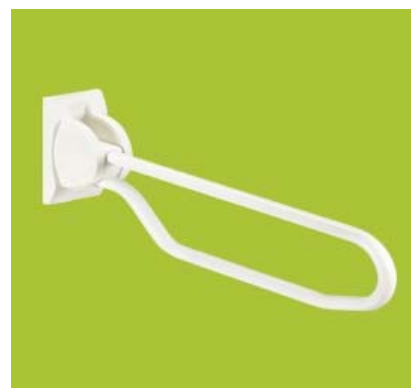
Problem Solved: A Linido hinged arm support which locks in the up position was installed into the wall. The Linido hinged arm support is available in 5 different lengths. The 700 mm (27.5") length was selected. There were no studs where the client needed the bar, so $\frac{3}{4}$ " plywood was installed as backing onto the two studs on either side of the desired location. The arm support is available when needed and safely locked in the "up" position leaving the area clear when not required.

Issues: To reduce the risk of the visually impaired person hitting a stationary object, a floor to ceiling pole or a Devon rail were rejected as alternatives. There was concern that a Devon rail could be accidentally pulled down if someone grabbed it and cause an injury. The super pole with bar could be used by some but not all the clients could lift the horizontal bar to move it out of the way.
